ENGINEERS - ARCHITECTS FORENSIC EXPERTS

June 2015

HAIL DAMAGE TO ASPHALT SHINGLE ROOFS

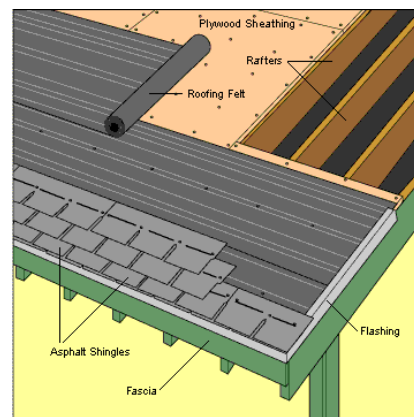
Drip edges of corrosion-resistant metal protect the roof edge. Roofing construction guidelines indicate shingles should overhang the drip edge. The tape over the self-sealing adhesives should be removed allowing for the shingles to self-seal. To assure proper maximum wind

performance, shingles must be installed on to a properly installed deck. Lack of proper attic ventilation and/or improper roof deck installation will likely cause thermal stresses and accelerated aging of the shingles.
